Town of Mooresville Drainage Study
Morgan County, Indiana

July 2016

Prepared By:
Joseph L. Miller, P.E., CFM

Prepared For:
Town of Mooresville

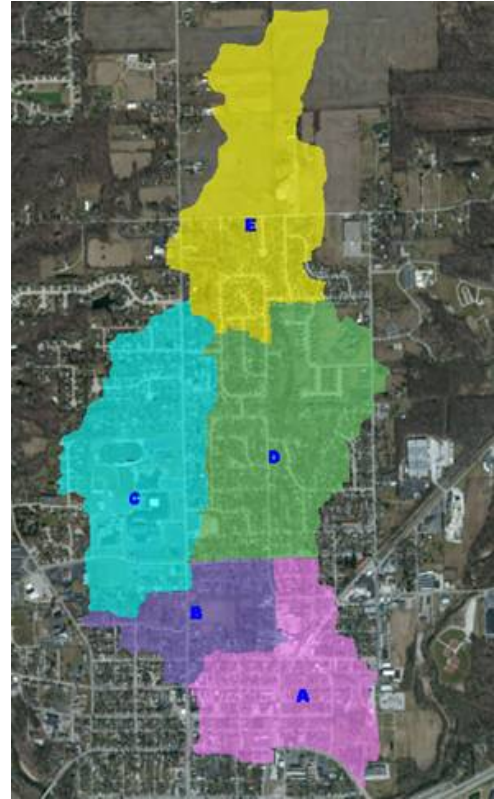
Figure 1: Watershed Boundary

The study area has been split into five separate areas, based on watershed boundaries and issues observed. These areas and overall watershed boundary are shown in Figure 1.

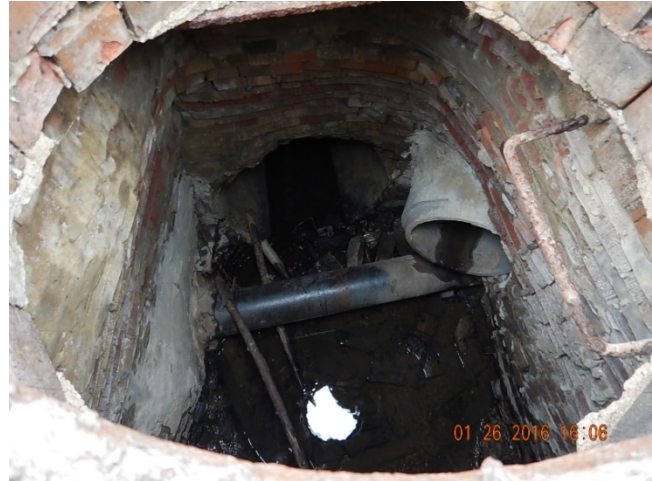
Photo 1: Northfield Drive Manhole

Storm sewer locations were observed within the watershed to develop accurate internal basin boundaries. During the course of the site visits, it was discovered that the condition of several manholes were deteriorating. For example, the masonry manhole located on Northfield Drive, shown in Photo 1, appears to have a water line running through it. Some of the bricks have fallen into the manhole along with other debris. This manhole connects the Westwood Drive ditch, from the north, to Edgewood Drive, to the West, and outlets into the ditch just West of Canaan Street. It is the primary outlet for Area E.

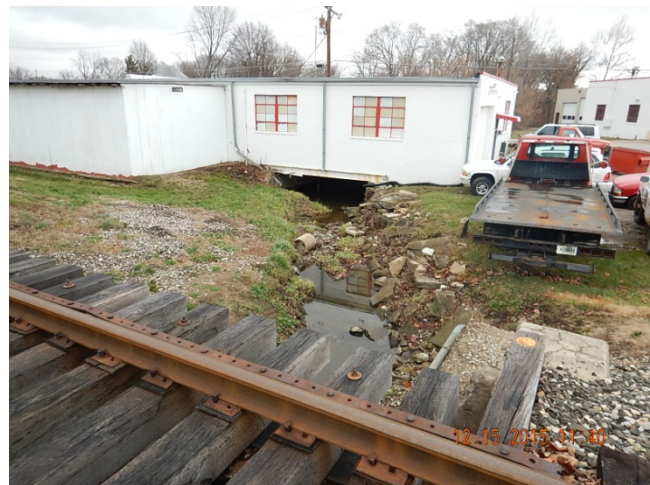
Photo 2: Building South of Railroad

In Area A, there were several industrial structures built across the ditch. These buildings, such as the one shown in Photo 2, restrict flow during larger storm events.

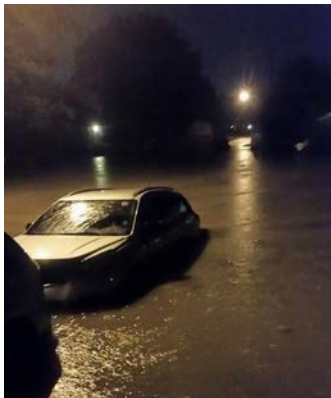
Photo 3: Submerged Car

A photo also surfaced on 8 WISH TV's website³, at an unidentified location in Mooresville Indiana, showing a car partially submerged at night. The photo, shown in *Photo 3*, was a courtesy of a Cassie Jo White. It is unknown where, in Mooresville, this photo was taken.

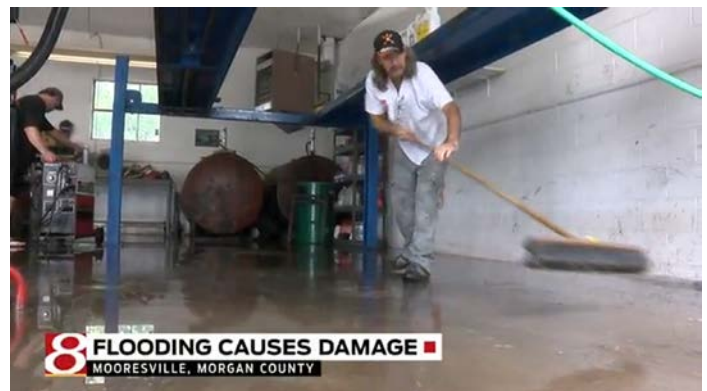
Photo 4: Big John's Auto Repair Shop

A video from the 8 WISH TV³ account shows flooding damages at Big John's Auto Repair Shop at 162 Taylor Street, shown in Photo 4. A house, also located on Taylor Street, appears to have flooding damage. Photo 5 was viewed from a Google Street photo taken not long after the storm event. A pile of carpet & debris is seen next to the street for trash pickup.

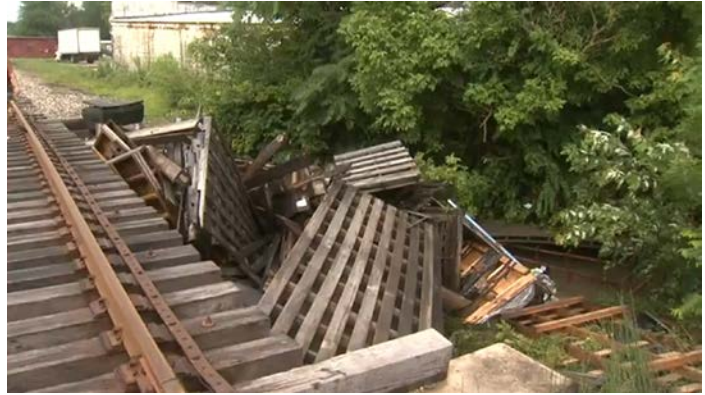
Photo 6: Railroad Trestle Blockage

Town Staff provided a tour of Area A. During this tour they indicated the Railroad Trestle, near Bolton Avenue and Taylor Street, had become blocked at some point prior to the major flood on July 12th. The pile of

Discussions with property owners within Area A indicated the flooding issues were magnified significantly by the blockage of the railroad trestle. Many reported water much higher than they ever experience before.

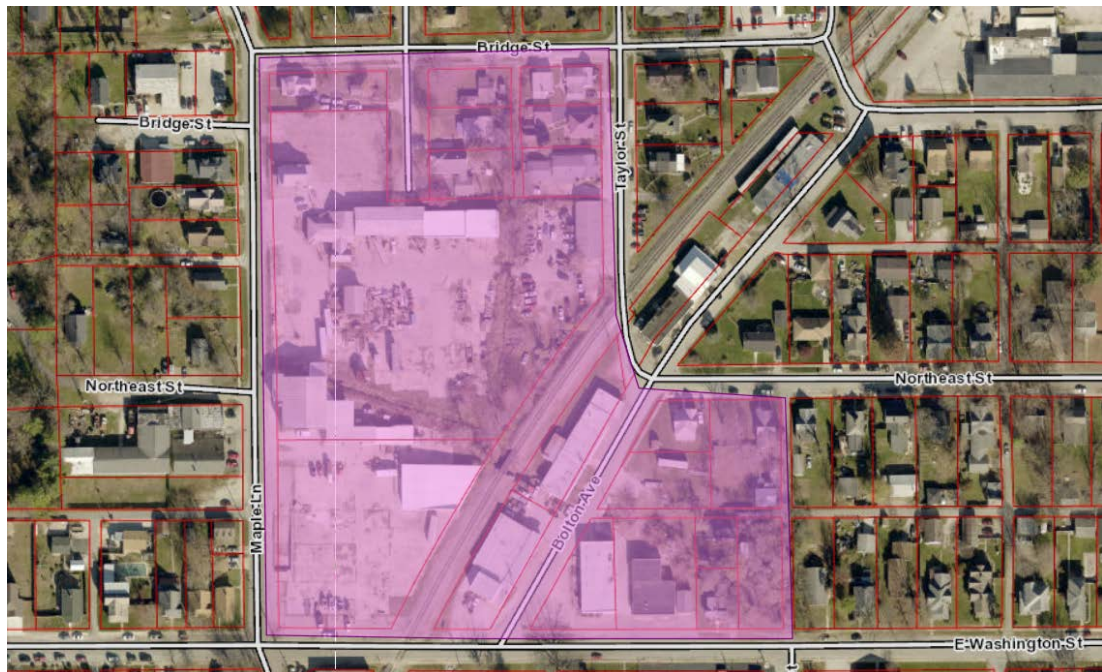
Figure 2: Area of Public Input within Area A

Property owner input for Area A was received predominately within the area bordered by Washington Street to the South, Maple Lane to the East and Bridge

Street to the North. This area was observed to have several structures over the ditch. Additionally, structures located next to the ditch have very little freeboard. Freeboard is elevation above the adjacent ground or flooding source. Figure 2 shows this location within Area A. One owner outside this area, 328 East High Street, expressed reoccurring impacts from flood waters.

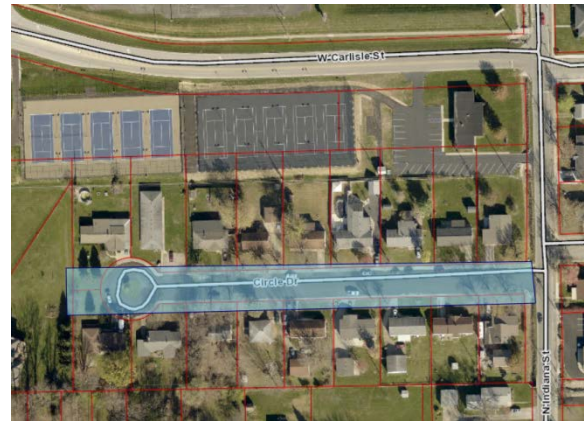
Figure 3: Area of Public Input within Area B

Town staff noted that issues have been expressed to them along Circle Drive just west of Indiana Street. Figure 3 shows this location. The reports state water from the west ponds and cannot go through a pipe west of Circle Drive. The water then proceeds over land as sheet flow across all of Circle Drive. Some vehicles parked on or near the road

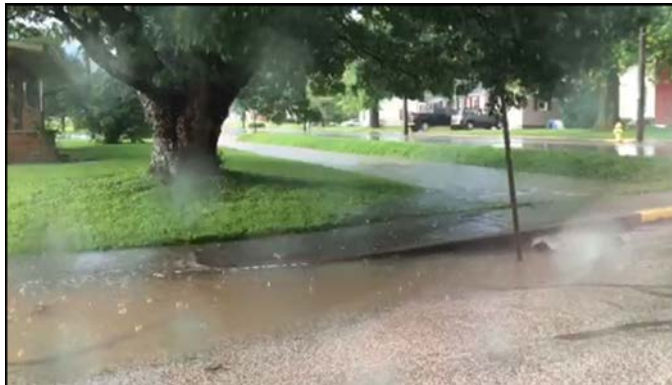
Photo 7: Storm Water at Circle Drive and Indiana Street

have reportedly been impacted. This claim is supported by Google Street photos showing vehicles drying out shortly after the floods on July 12, 2016. Photo 7 shows flowing storm water. It was taken standing on Circle Drive looking northeast to Indiana

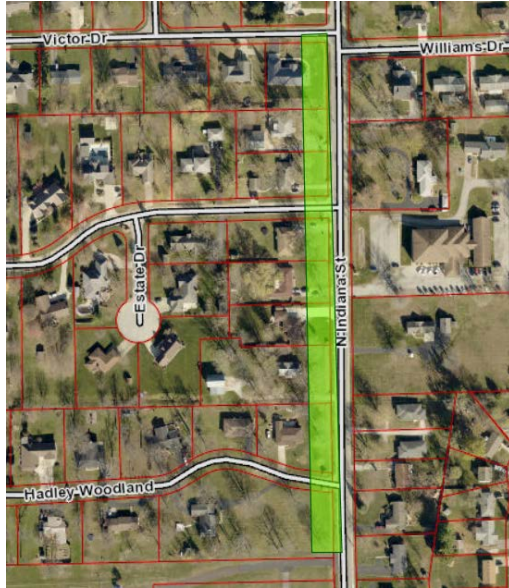
Figure 4: Area of Public Input within Area C

Area C had primary public input north of Mooresville High School along Indiana Street. Residents within this area expressed they had trouble mowing the ditch along Indiana Street. Others expressed they filled there portion of the ditch many years ago. There were no reports of structure or vehicle flooding within this area. Figure 4 shows the area where the most residents expressed opinions about the ditch being studied.

During the tour with Town Staff, an area along Carlisle Street at the Southwest corner of the School property was viewed in detail. This area was noted as an area where, during periods of intense rainfall, stormwater jumps watersheds and heads southeast to the study area of this report. It was also reported the ditch being studied has overtopped Carlisle Street and proceeds towards Circle Drive in Area B as well.

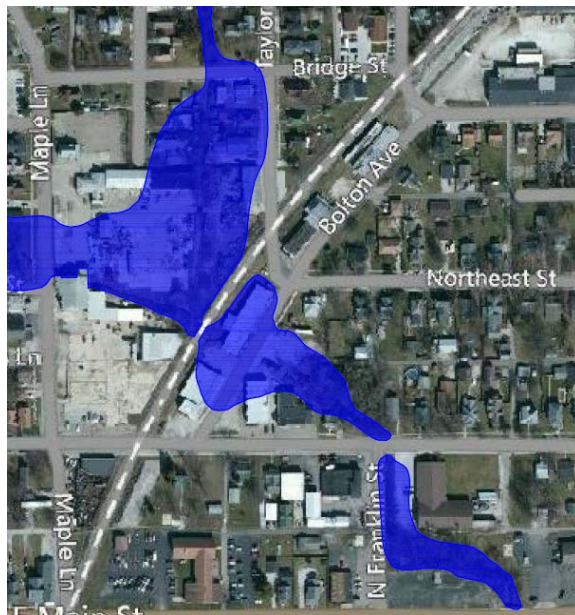
Figure 6: Primary 100-Year Floodplain Area A

100-Year Flood modeling within Area A noted sixteen structures located within the 100-year floodplain. All but one of these structures was located between

Washington Street Maple Land and Bridge Street. The one other structure was located at 328 East High Street. The structure at 328 East High Street is also impacted by backwater from East Fork of White Lick Creek. The lowest adjacent grade of this structure is nearly 5 feet below the 100-year base flood elevation from the East Fork of White Lick Creek. Figure 6 shows the predominant areas of flooding for Area A.

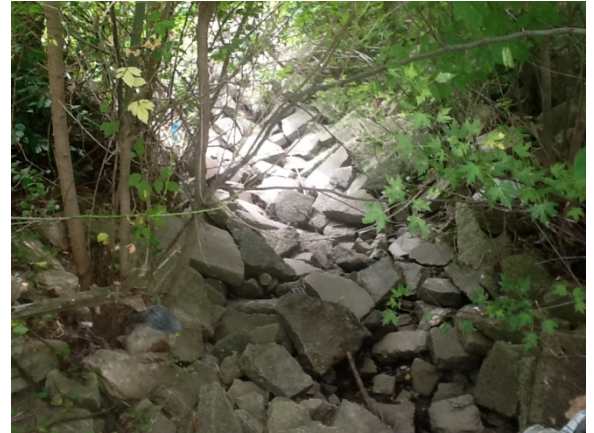
Photo 8: Channel between Washington & RR

The first primary issue with this area is the relatively small channel size from railroad trestle downstream to Washington Street. Additionally, sediment has accumulated under the railroad trestle, under the building at 210 Bolton Avenue, and under a private crossing at 246 East Washington Street. The site specific survey of the area shows indicates several low spots within this area that hold water on a regular basis. There is nearly 4 feet channel fall within the 500 feet +/- from the upstream side of the railroad trestle to East Washington Street. The majority of that fall, however, occurs between the private crossing and East Washington Street. Photos 8 and 9 show the difference in channel size. Photo 7 was taken while standing on the private crossing at 210 Bolton Avenue.

The ditch downstream of Washington Street is in reasonable condition. Upstream of Washington Street however the ditch is in need of maintenance. Significant sediment and debris has accumulated within this reach and the capacity has become limited. Photos 8 and 9 within previous sections show the dramatic difference in channel flow area upstream and downstream of Washington Street.

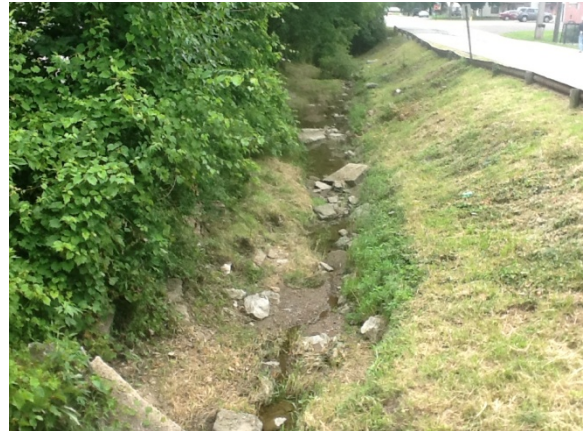
Photo 9: Channel Downstream of Washington St.

The second primary issue is the flat topography and intense development behind the railroad trestle. The modeling shows this area to be a rather large floodplain when compared to other areas within the study reach. This area is at the confluence of the two primary channels in the study reach. The current land use for the area is predominately industrial/commercial which lessens infiltration and increases runoff.

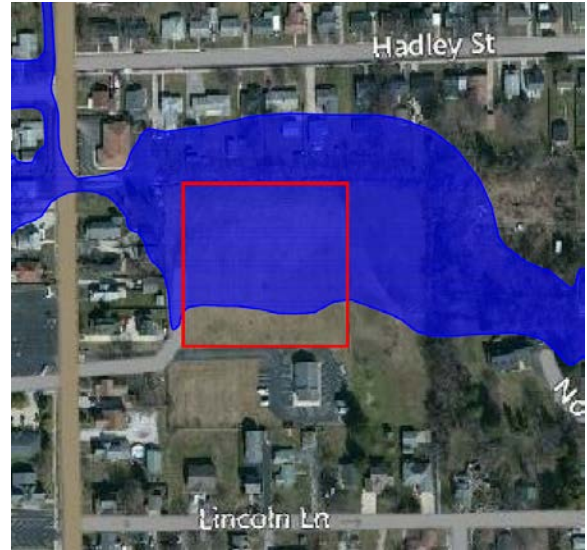
Figure 7: Area B Undeveloped Subdivision

One item that come up during the study of Area B is a new subdivision located just downstream of Indiana Street along the open ditch. None of the structures are built yet, but nearly all of the 13 lots are located within the delineated 100-year floodplain. When fully developed this area will likely either take away existing floodplain storage for the reach or have structures located within the floodplain. This area is shown in Figure 7.

No structures appear to be within the 10-year floodplain within Area B. However, the 10-year floodplain does appear to affect about half of the undeveloped subdivision lots located just downstream of Indiana Street.

Area B was the one area of the modeling where calibration was more difficult. The watershed jumping that occurs at the southwest side of the school is difficult to quantify. We believe the 100-year floodplain along Circle Drive and just downstream may be shown on the maps slightly larger than what is documented in the field.

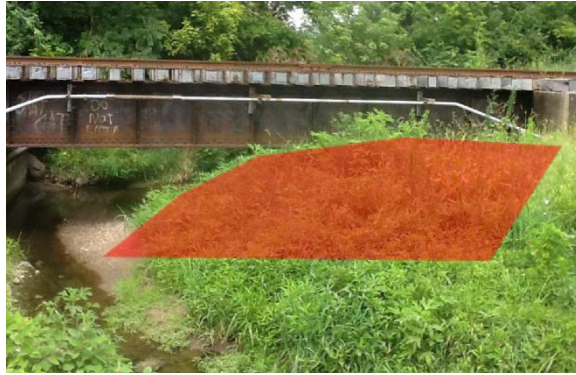
Photo 10: Accumulated Sediment Under at RR

It is also noted that there is a large amount of sediment under the railroad trestle. See Photo 10 for a view of the sediment accumulated. The large amount of sediment accumulated tends to catch additional sediment or debris such as the pallets that blocked the trestle in July of 2015.

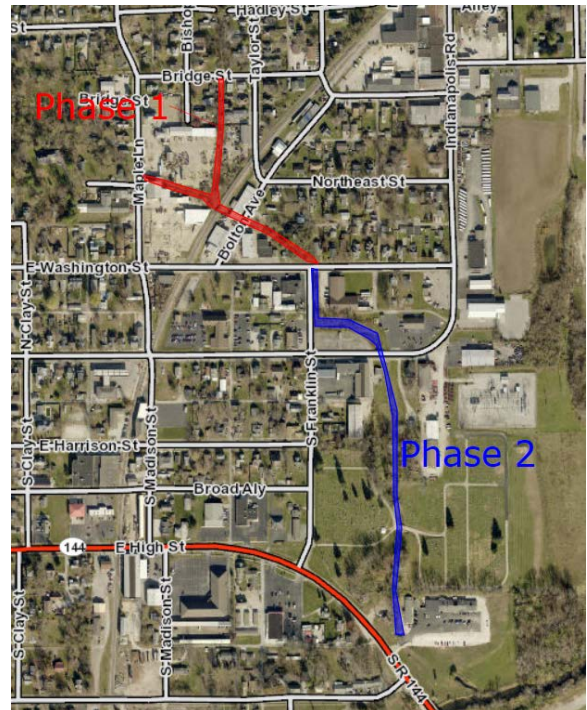
Figure 8: Project A-1 Map

from property owners along the reach to be cleaned. It is recommended Phase 1 of the work start at Washington Street and proceed upstream to both Bridge Street and Maple Lane. Phase 2 would begin at the Squelers Barbecue Grill entrance and proceed upstream to Washington Street. Figure 8 shows the locations of Phase 1 and 2 of this project.

The cleaning of the ditch will benefit Area A for the more frequent storms up to roughly a 10-year frequency. During larger events the ditch cleaning will have little or no effect on peak elevations, but it will lessen the likelihood of debris accumulating and causing significant issues such as those observed in July of 2015.

Significant challenges exist in order to perform this maintenance along the ditch. It is our understanding that no easements for the ditch exist throughout most of the reach. There is only a small portion of the ditch within Area A that is under Town control or along right of way for access. In order to clean the ditch the Town will need to acquire a hold harmless right of entry or easements

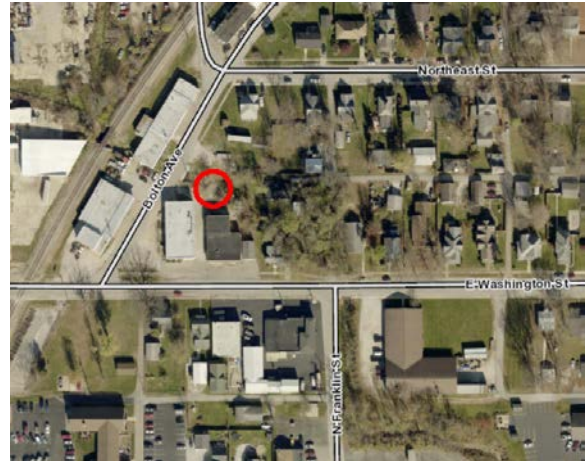
It is recommended, if private crossings are no longer in use they be removed. At least one such structure appears to be in place at 246 East Washington Street. The properties this crossing ties together is owned by two separate parties. The cost to remove this structure should be \$5,000 or less. It would ideally be performed as part of the work within Project A-1. The benefit for this project would be most prevalent in the more frequent storm events 10-year and less, but as with Project A-1 removing the structure eliminates a potential place for debris to accumulate along the reach. There is approximately 1.5 feet of flood elevation difference from the downstream to upstream side of this structure during a 10-year event. See Figure 9 for the location of this project. As with Project A-1 approval by the landowner would have to be granted prior to completing this project.

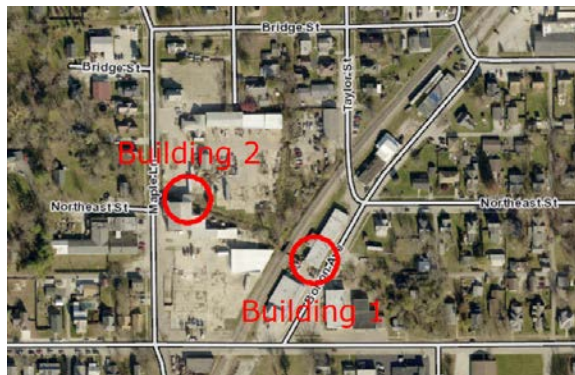
**Figure 10: Project A-3 Map**

At two locations within Area A buildings have been built across the ditch. This project will not be possible in the near future, but long term planning to eliminate these hazards is recommended. There could be two approaches to achieve this. The first approach could be to re-align the ditch around the buildings. The second would be to remove a portion of the building. Obviously, these would either have to be completed by

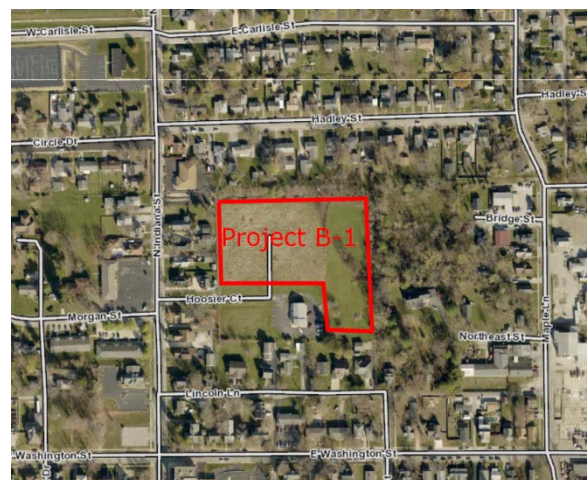
The estimated construction costs for a maximized offline detention facility as Project B-1 is approximately \$440,000. This estimate includes land acquisition and soil haul away estimates which can be highly variable. Construction costs could be significantly with a smaller scale project, or eliminated totally with just the maintaining of green space. The potential benefit would be reduced

accordingly. The location of the potential Project B-1 is shown on Figure 11.

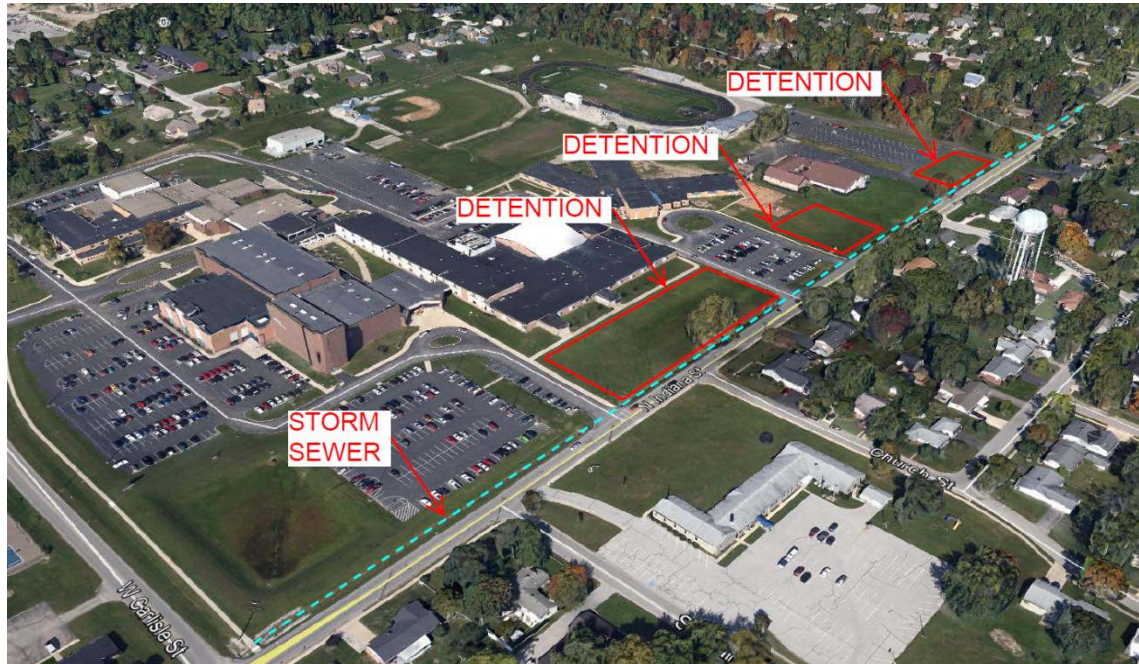
Figure 12: Project C-1 Map

total of 3 acres +/- . This detention would be similar to the dry pond at the intersection of W Carlisle Street and Indiana Street. The combined storage of these three preliminary layout is approximately 5 acre-ft.

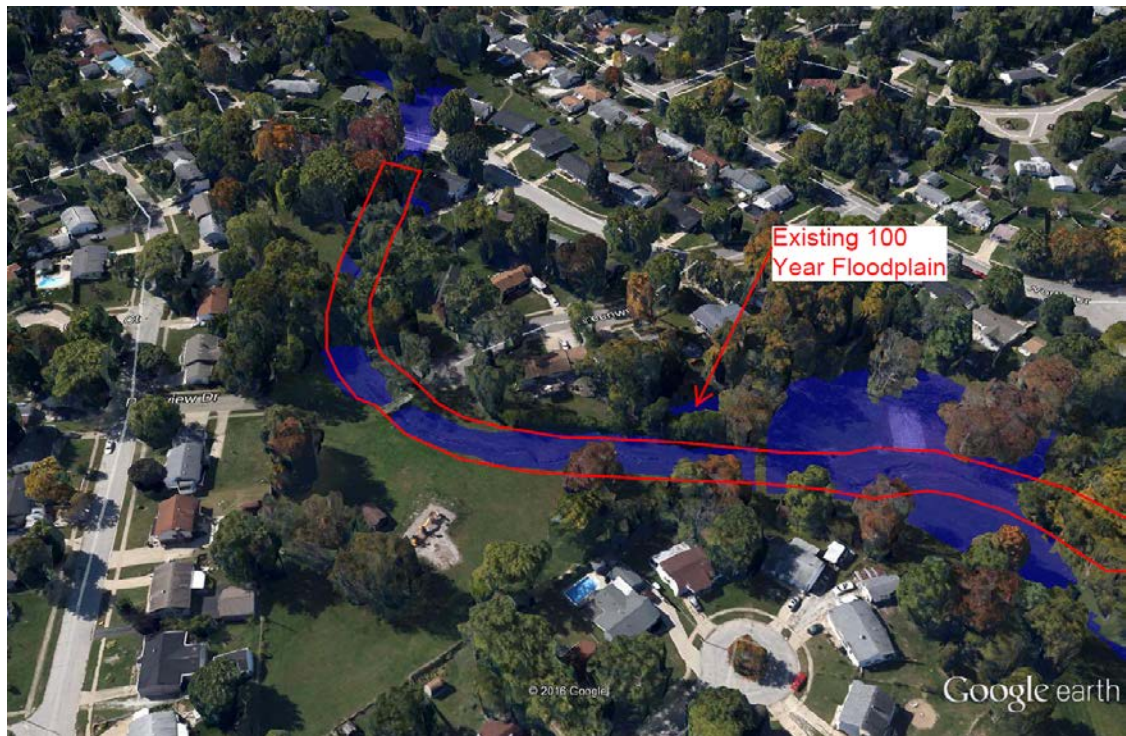
Figure 13: Project D-1 Map

The purpose of this alternative is to provide additional storage within North Park to offset increased flows from Area E prior to entering Area A. Figure 13 shows the approximate location of this project. For Projects that increase flowrates from Area E Project D-1 was added to it. Results of that combined study will be documented for potential projects for Area A. Project D-1 by itself, while beneficial in the localized area does not carry benefit significantly downstream. There are no structures currently within the floodplain in Area D to benefit. The estimated construction cost of Project D-1 is \$90,000.

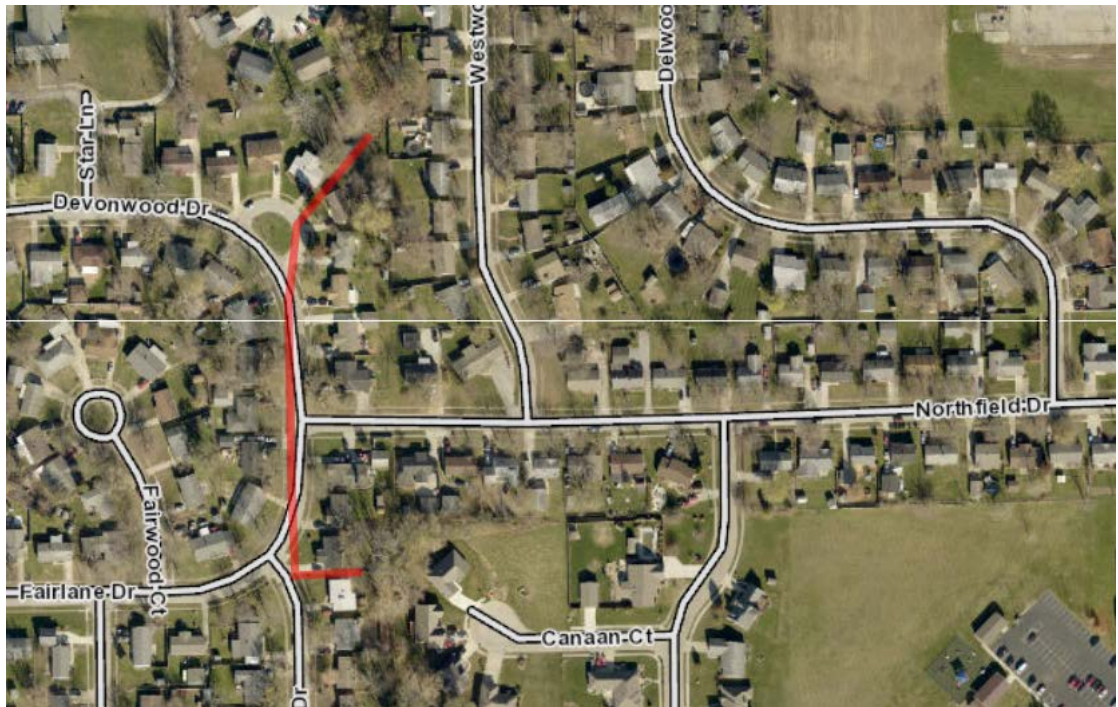
Figure 14: Project E-1 Map

Project E-1 evaluated additional capacity through Northfield Drive. This could be done in one of two ways. The first way would be through direct replacement of the pipe. The second way is by running a pipe from the ditch to the north, through the intersection of Northfield and Edgewood Drives, then outlet it into the open ditch downstream of Northfield Drive. A schematic of Project E-1 is shown in Figure 14.

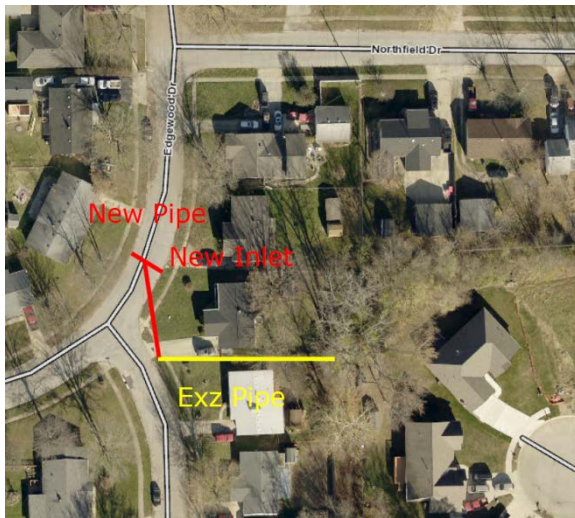
Figure 15: Project E-2 Map

Since the large bypass pipe has adverse effects downstream, a less aggressive approach would be to tie into the existing storm sewer at the intersection of

Fairlane and Edgewood Drives. There is a 21 inch clay tile that serves as the primary outlet for this area. The tile appears to be low enough to be able to tie into and assist in draining the low intersection of Northfield and Edgewood Drives.

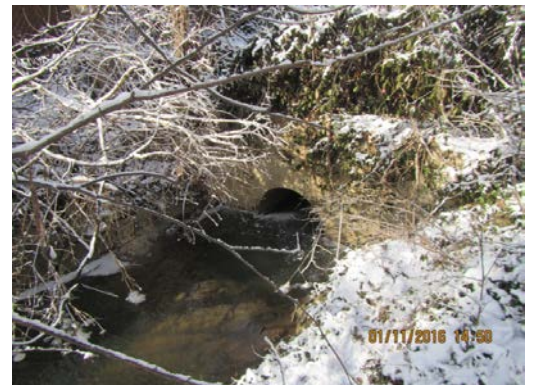
Photo 11: Outlet South of Northfield Drive

During the field reconnaissance portion of the project observations were made at the 36 inch pipe outlet downstream of Northfield Drive. There appeared to be debris and sediment blocking a

portion of the pipe. This area is hard to access, but needs to be cleaned out to help maintain capacity through the pipe. This could likely be completed with Town staff. If an outside contractor were to complete the work it should not cost more than \$5,000. Photo 11 shows the water against the pipe outfall.

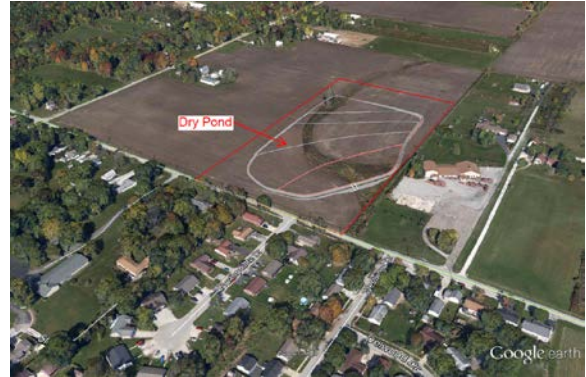
Figure 16: Project E-4 Detention

The only project that fully rectifies both flooding regimes within Area E is Project E-4. It is a two-pronged approach. First a proposed dry detention basin is to be installed on 12 acres acquired within Hendricks County. A five foot tall berm, with a 15 inch outlet would be constructed across the ditch. The storage available in this basin is approximately 19 acre-ft. The detention facility is shown in Figure 16. This dry

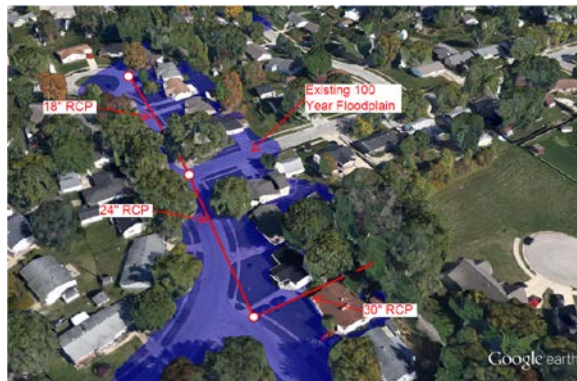
Figure 17: Project E-4 New Pipe

Edgewood Drives. The new pipes will serve as the primary outlet for the low area and the 30 +/- acres of overland flow draining to it. As long as the pipes or inlets do not become clogged this alternative will provide protection for the adjacent houses for the 100-year event. Figure 17 shows the

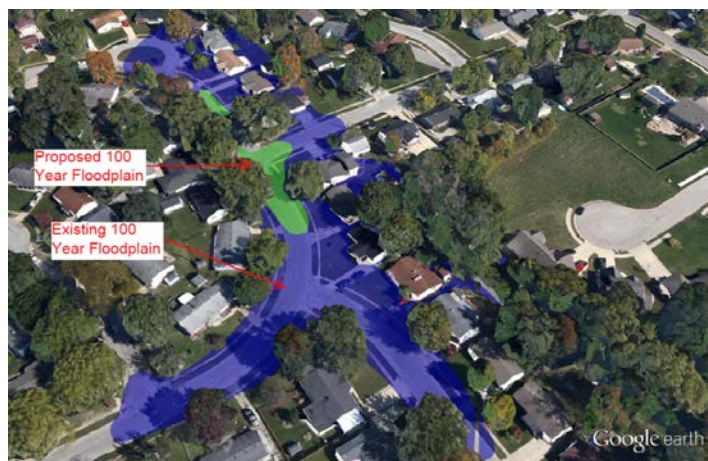
Figure 18: Project E-4 Benefits

The second portion of this project is installation of new outlet pipes for the intersection of Northfield and

approximate location of the proposed pipes. Figure 18 shows the impact of the full project.

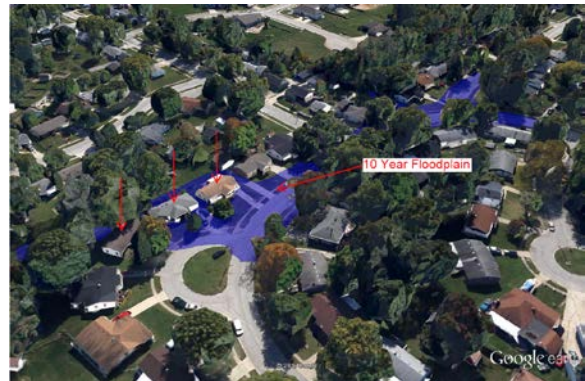
Figure 19: Project E-5 Location

Three houses currently get hit with water overflowing from the ditch between Highland Meadows and Northfield Park in during the 10-year event. An option exists to purchase the houses and eliminate the risk. After purchase the houses would then be demolished. It is estimated that the cost to purchase the houses would be approximately \$270,000. This does not include demolition or professional services. Demolition could be performed as training for local fire departments if allowable.

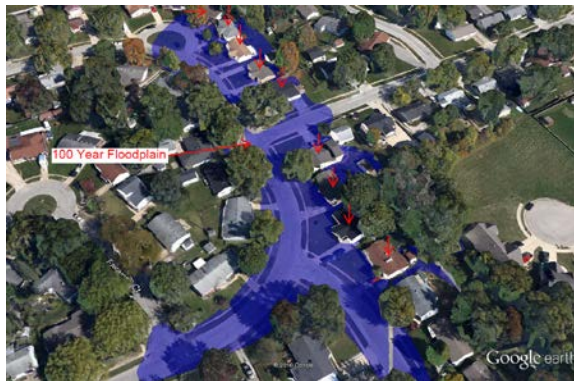
Figure 20: Project E-6 Location

Up to nine houses have been hit with flood waters along Edgewood Drive. One alternative is to purchase all nine houses and turn the area into green space or a park. This would eliminate the significant risk for flooding within the area. It is estimated that the cost to purchase the houses would be approximately \$900,000. This does not include demolition or professional services. Demolition

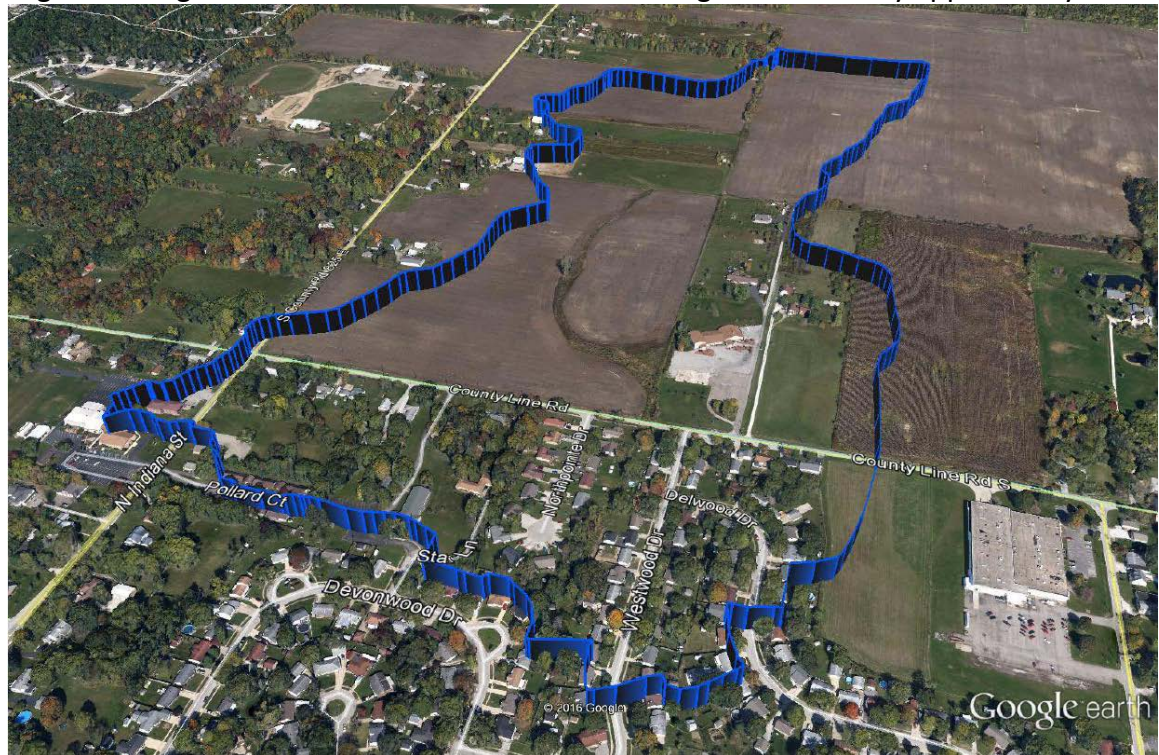
Figure 21: Drainage Impact Area

This programmatic project will limit discharges from upstream development within the watershed. While not an immediate fix, over the course of time the limited discharge from development will allow the pipe under Northfield Drive to handle larger and larger storm events. The critical item is to get this not only approved by

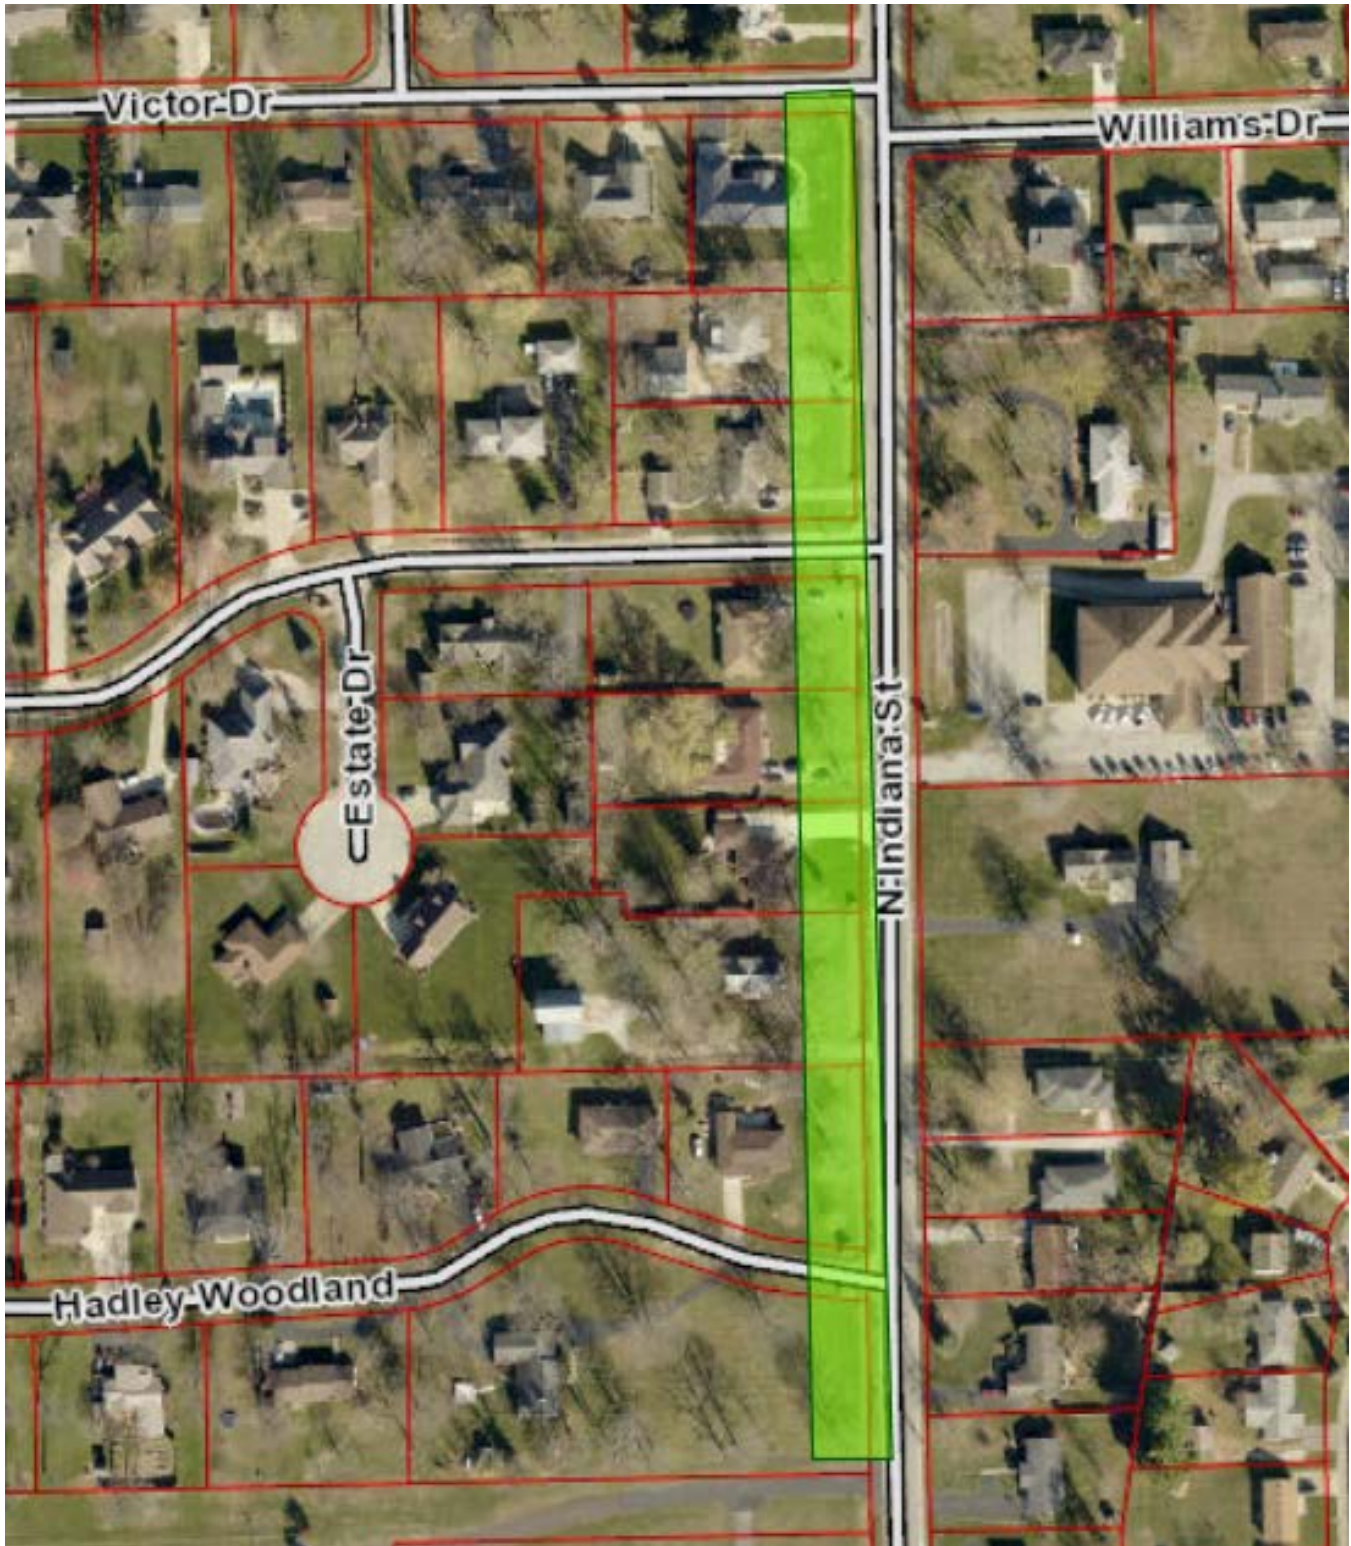
Figure 5 Area of Public Input within Area E

Area E was another area with significant public input. The primary location for this was bordered on the south by Northfield Drive, on the west by Edgewood Drive and to the east by Westwood Drive. Structure flooding at approximately 10 residents was reported during the July 2015 event. Figure 5 shows the location of the primary public input

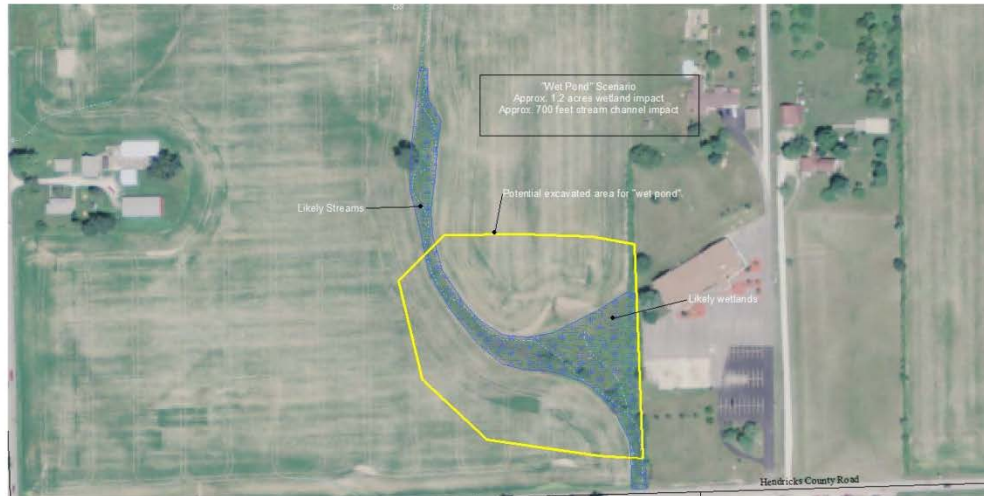
Figure 1 Example of "Wet Pond" scenario

Compensatory mitigation costs could run \$30k - \$60k per acre of wetland impact, and stream mitigation costs could run \$30 - \$50 per linear foot. Consulting costs for wetland delineation, IP permitting, and mitigation planning would run approximately \$20k - \$30k.

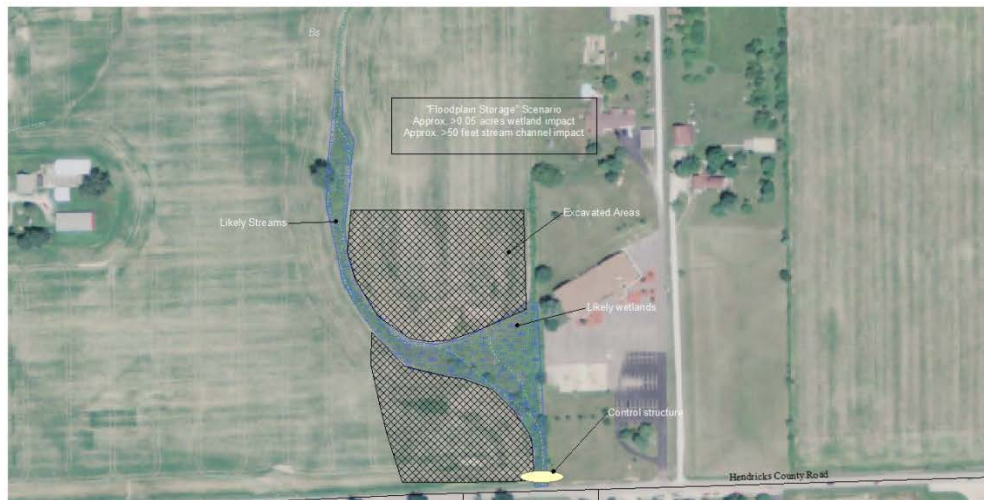
Figure 2 Example of "Floodplain Storage" scenario

The second scenario we discussed centered on excavation of areas adjacent to the existing wetlands/streams; to create something functionally similar to floodplain storage areas. This concept involves excavating areas outside of the wetland boundary, and limiting the fill material discharge/impact to jurisdictional waters, to just a control structure. This scenario demonstrates a comprehensive avoidance and minimization of wetland/stream impacts, and would likely result in permit issuance. Although permit applications to Corps and IDEM would still be required, since the fill material discharge could be limited to less than 0.1 acre, mitigation is unlikely to be required.

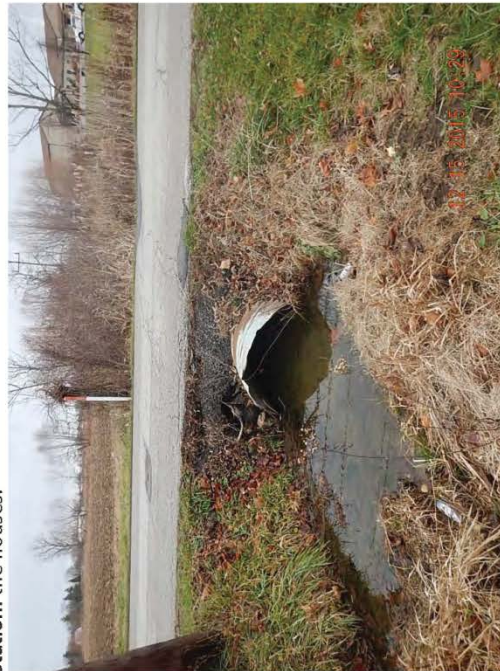
Photo 55: Culvert under E. County Road 900 South
Station: 215
